ADS FOR RURAL AMERICA

Phase 1 (Controlled-Access Divided Highway/Interstate)

Evaluation Report

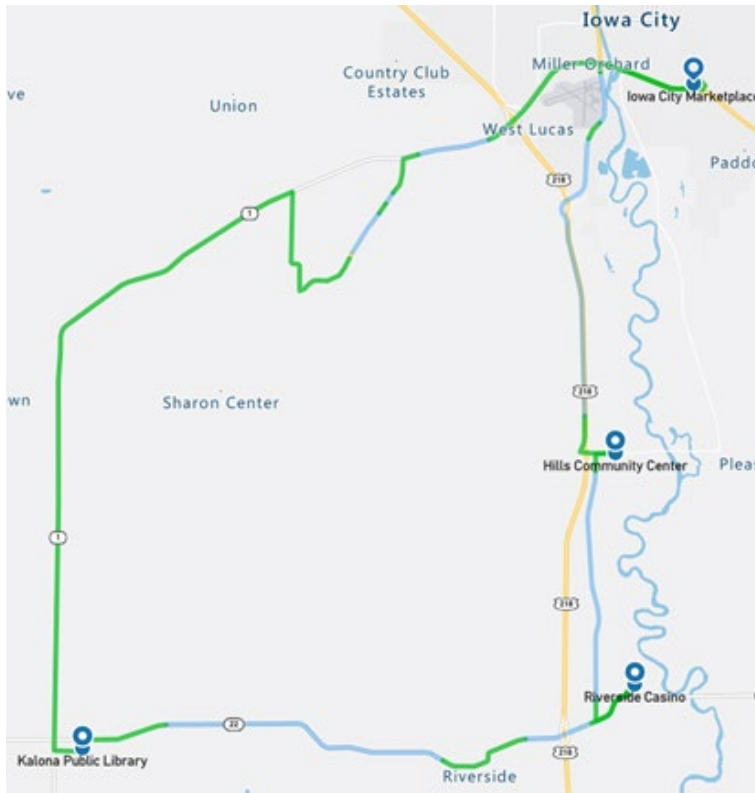
Number of miles recorded	48.03
Number of miles recorded in automated mode	17.65
Percent of drive recorded in automated mode	36.70%
Amount of data collected (GB)	87.2
Weather conditions	Clouds: 90% Rain: 5%, Clear: 5%
Time of day	Noon
Day of week	Weekday

Figure 4. Drive 2 automation engagement

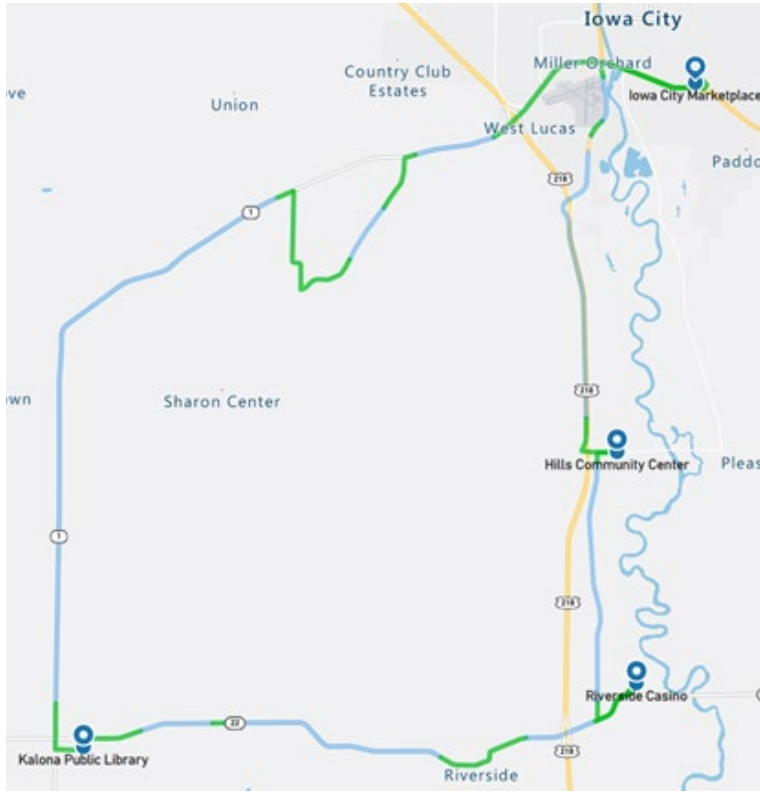
Number of miles recorded	48.03
Number of miles recorded in automated mode	28.09
Percent of drive recorded in automated mode	58.50%
Amount of data collected (GB)	78.2
Weather conditions	Clear: 57%, Clouds: 43%
Time of day	Mid-afternoon
Day of week	Weekday

Figure 8. Drive 6 automation engagement

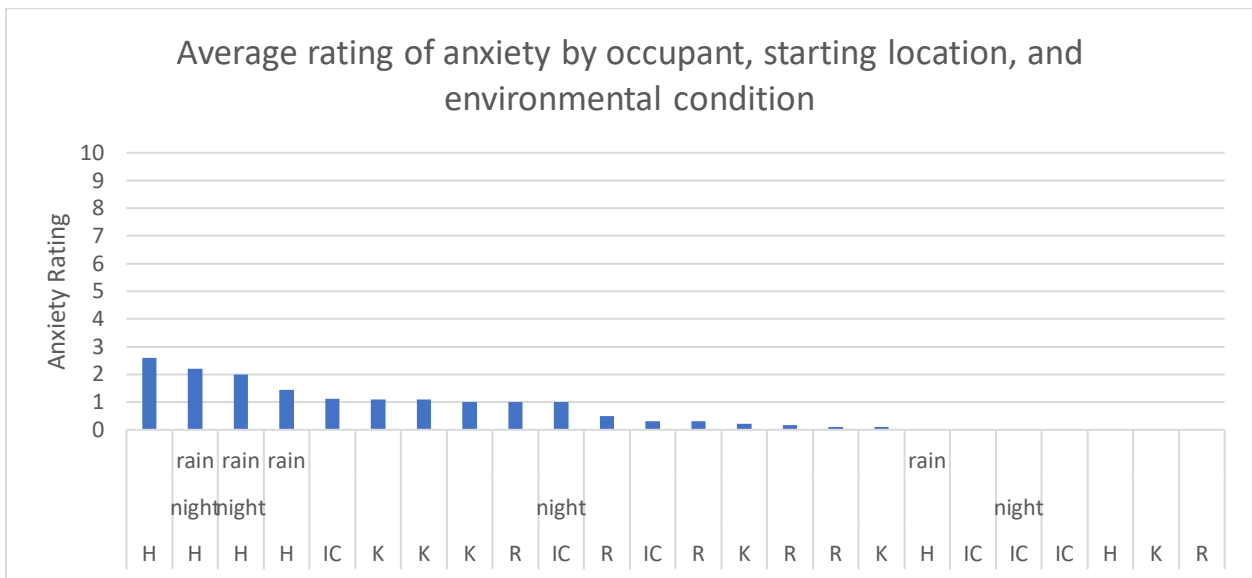
Anxiety ratings were also examined for each occupant based on weather conditions, time of day, and starting location (Figure 25). The combination of rain and nighttime driving seemed to produce an increase in average anxiety ratings. Also, occupants who began their drive in Hills (H) had higher average anxiety ratings than those who started in Iowa City (IC), Kalona (K), or Riverside (R). This may be due to the higher number of drives at night and in the rain that began in Hills. On average, males rated their anxiety higher than females (0.93 vs. 0.49, respectively).

Figure 25. Average anxiety rating by occupant, starting location, and environmental conditions (H=Hills; IC= Iowa City; K=Kalona; R=Riverside)

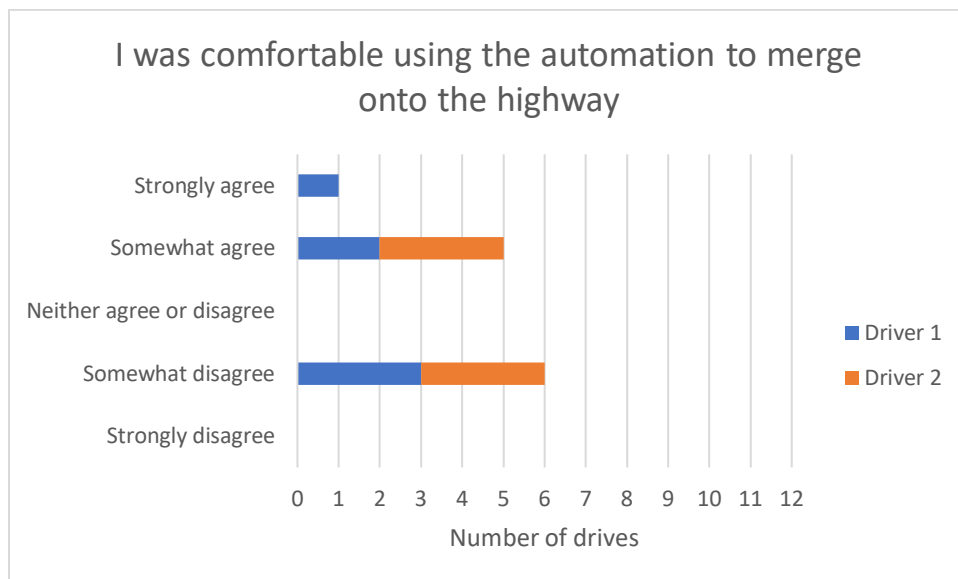
Figure 27. Safety driver perception of automation during merge onto highway

There were 2 dedicated safety drivers for Phase 1, each one drove six of the twelve drives. They were asked to complete a post-drive survey after each of their drives. These questions were related to their comfort using the automation at different points during the drive or during certain environmental conditions. For Phase 1, automation was used mainly on the highway portions of roadway. Results of the survey showed that drivers were comfortable using the automation during these roadway segments (Figure 26). However, they were less comfortable when using the automation to complete the merge onto Highway 218 (Figure 27). There were a couple of instances of abrupt lane changes and inappropriate braking that may have led to these results.
