# ADS FOR RURAL AMERICA

Phase 2 (Two Lane Undivided Highway and On- and Off-ramps)

## Evaluation Report

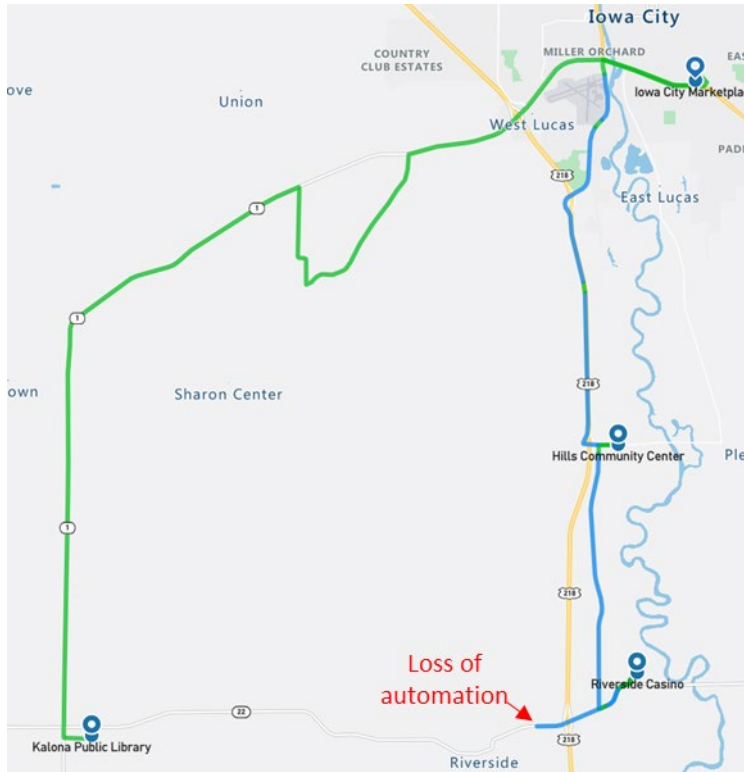
Start Location	Kalona
Number of miles recorded	48.09
Number of miles recorded in automated mode	12.99
Percent of drive recorded in automated mode	27.00%
Amount of data collected (GB)	83.1
Weather conditions	Avg temp: 33 (F) Clear: 100% Avg wind speed: 8.5 mph
Time of day	Mid-morning
Day of week	Weekday

Figure 20. Drive 30 automation engagement (March 8, 2022)

As shown in the map in Figure 20, there was a loss of automation as the vehicle was entering Riverside. The communication between the GNSS receiver and the Spectra computer stopped. From that point forward, the localization module was no longer able to publish localization data to the stack, and thus all downstream modules stopped publishing. In essence, the safety driver was able to engage automation, but none of the automated systems were operable. In order to troubleshoot and develop a mitigation strategy, and not cause excessive delays to the project timeline, the final three drives that were planned for Phase 2 were not completed at this time but were pushed to Phase 3. The technology provider explored the reason for the loss of communication and attributed it to a transient failure which caused the NovAtel GNSS to reboot, resulting in a stopped flow of data. The reason for the NovAtel reboot remains unknown and has not been replicated despite extensive testing.

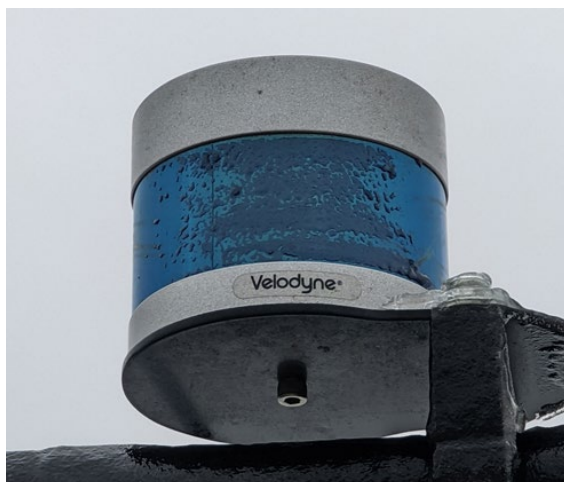
Figure 37. Obscured lidar located on the top of the AV
