ADS FOR RURAL AMERICA

Phase 3 (Urban Driving – Roads through Cities and Towns)

Evaluation Report

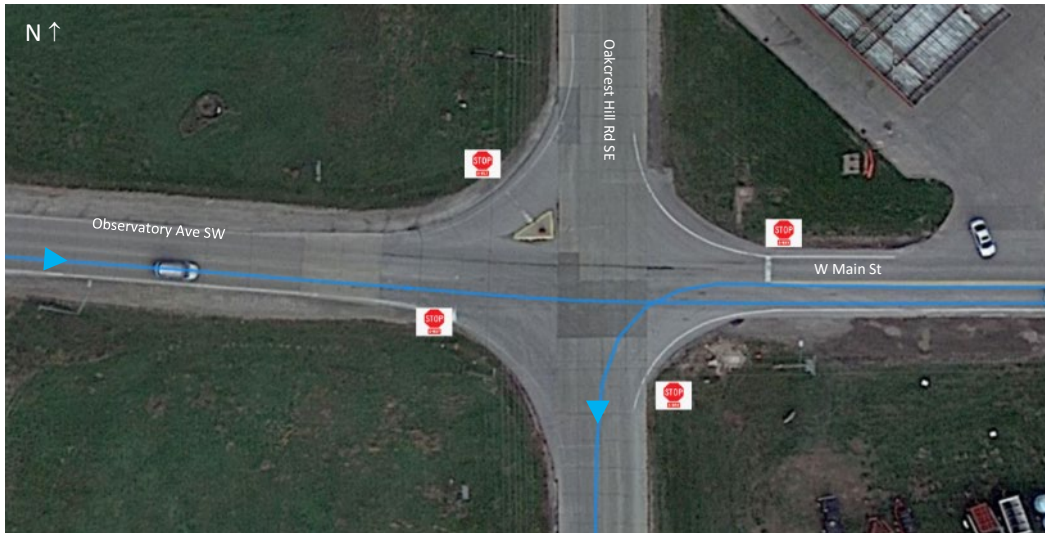
1. After the turn onto Observatory Avenue SW, the vehicle stopped at the 4-way stop sign at the intersection of W Main St and Oakcrest Hill Rd SE. If it was considered safe to allow it to do so, the vehicle traveled through the intersection under automation. If not, automation was disengaged. Automation was re-engaged once it was safely through the intersection. Automation was then used for the drive through Hills before it came back to this intersection and stopped at the 4-way stop sign at the intersection of W Main and Oakcrest Hill Rd SE. If it was considered safe to allow it to do so, the vehicle made the left turn from W Main heading south on Oakcrest Hill Rd SE in automation. If not, automation was disengaged and re-engaged once it reached the appropriate speed.

Figure 3. 4-way stop in Hills

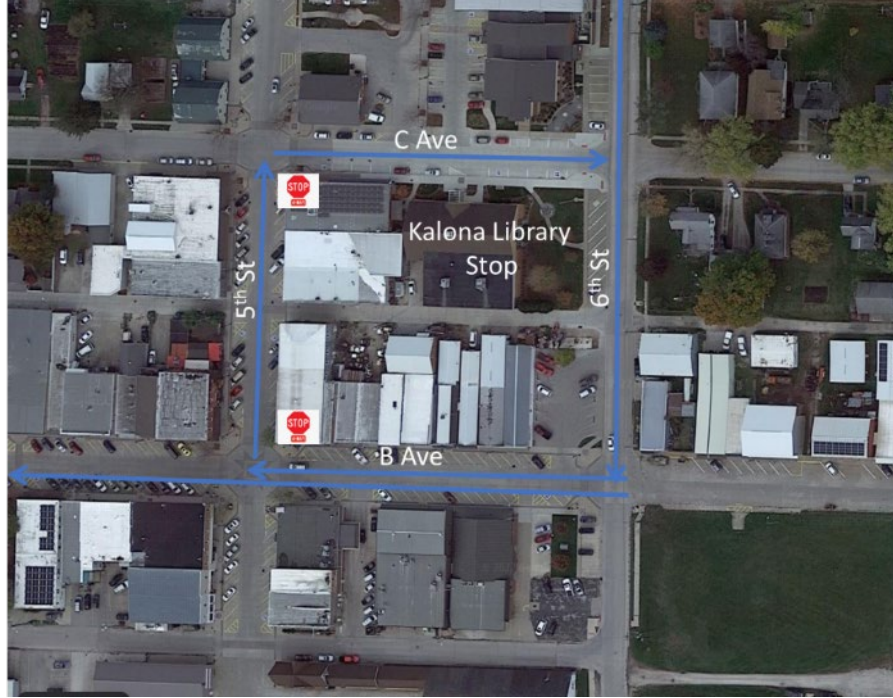
2. In downtown Kalona, the vehicle stopped at the 4-way stop sign at the intersection of B Ave and 5th St. If it was considered safe to allow it to do so, the vehicle made a right turn under automation. If not, automation was disengaged. Automation was re-engaged once the vehicle completed the turn. The vehicle stopped at the next block for the 4-way stop sign at the intersection of 5th St and C Ave. If it was considered safe to allow it to do so, the vehicle made the right turn onto C Ave in automation. If not, automation was disengaged and re-engaged once the turn was complete. After stopping at the Kalona Library, the vehicle went around the block to exit Kalona on B Ave. The vehicle stopped again at the 4-way stop sign at the B Ave and 5th St. This time, if it was considered safe, the vehicle would travel straight through the intersection. If not, the automation was disengaged and re-engaged once it had passed through the intersection.

Figure 4. 4-way stops in downtown Kalona

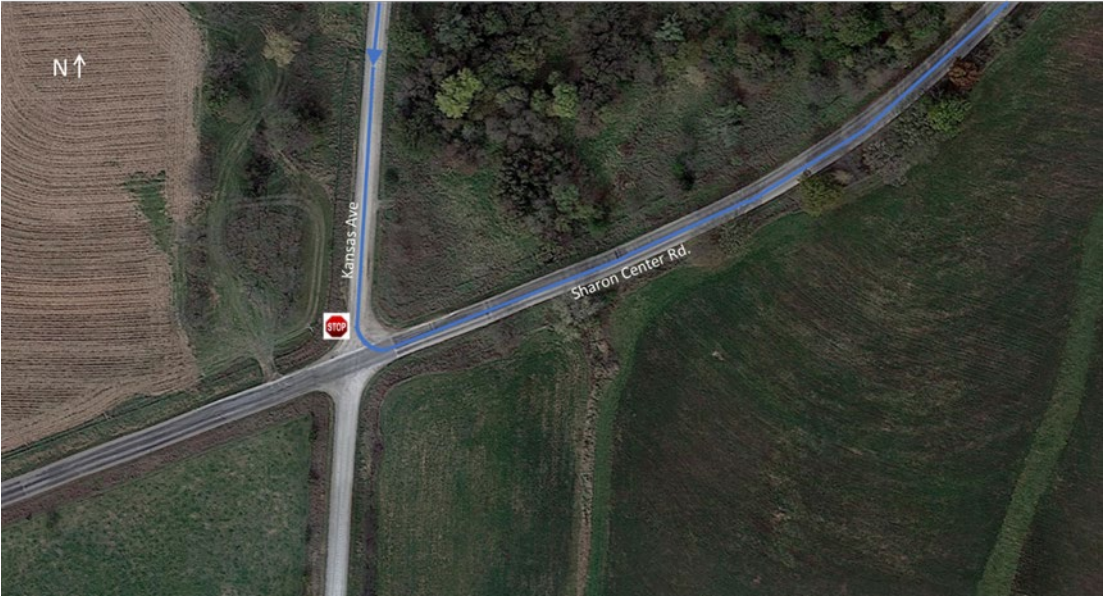
- 3. The vehicle activated the turn signal and stopped at the stop sign at the intersection of Kansas Ave and Sharon Center Rd. If it was considered safe to allow it to do so, the vehicle may have completed the left turn onto Sharon Center Rd. If not, the automation was disengaged and re-engaged once the vehicle reached the appropriate speed.

Figure 9. Left turn onto Sharon Center Rd

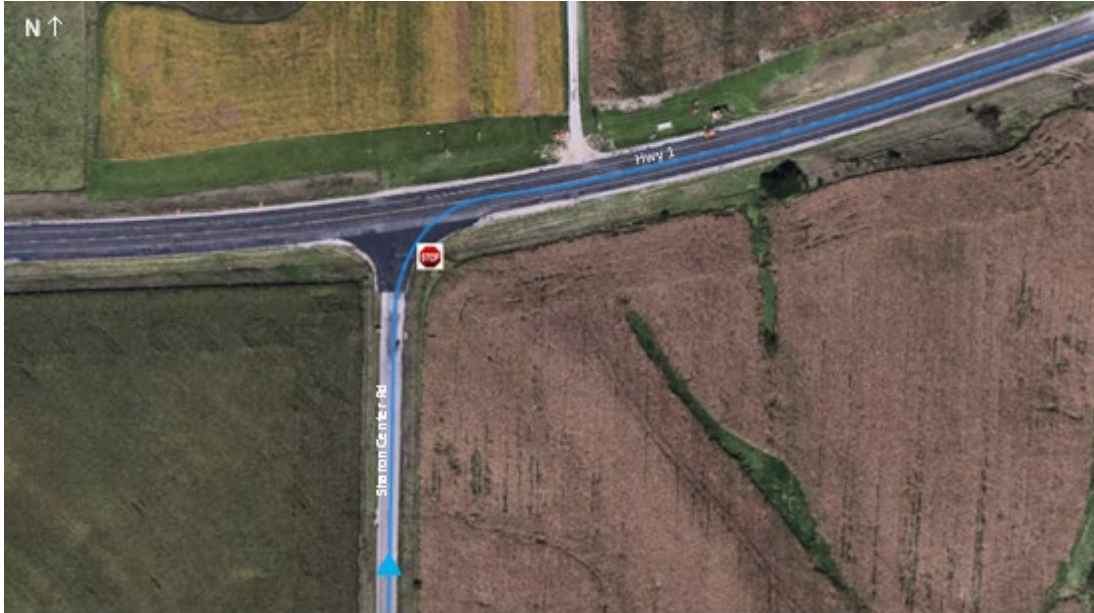
3. The vehicle activated the turn signal and stopped at the stop sign at the intersection of Sharon Center Rd and Hwy 1. If it was considered safe to allow it to do so, the vehicle may have completed the right turn onto Highway 1. If not, the automation was disengaged and re-engaged once the vehicle reached the appropriate speed.

Figure 13. Right turn onto Hwy 1

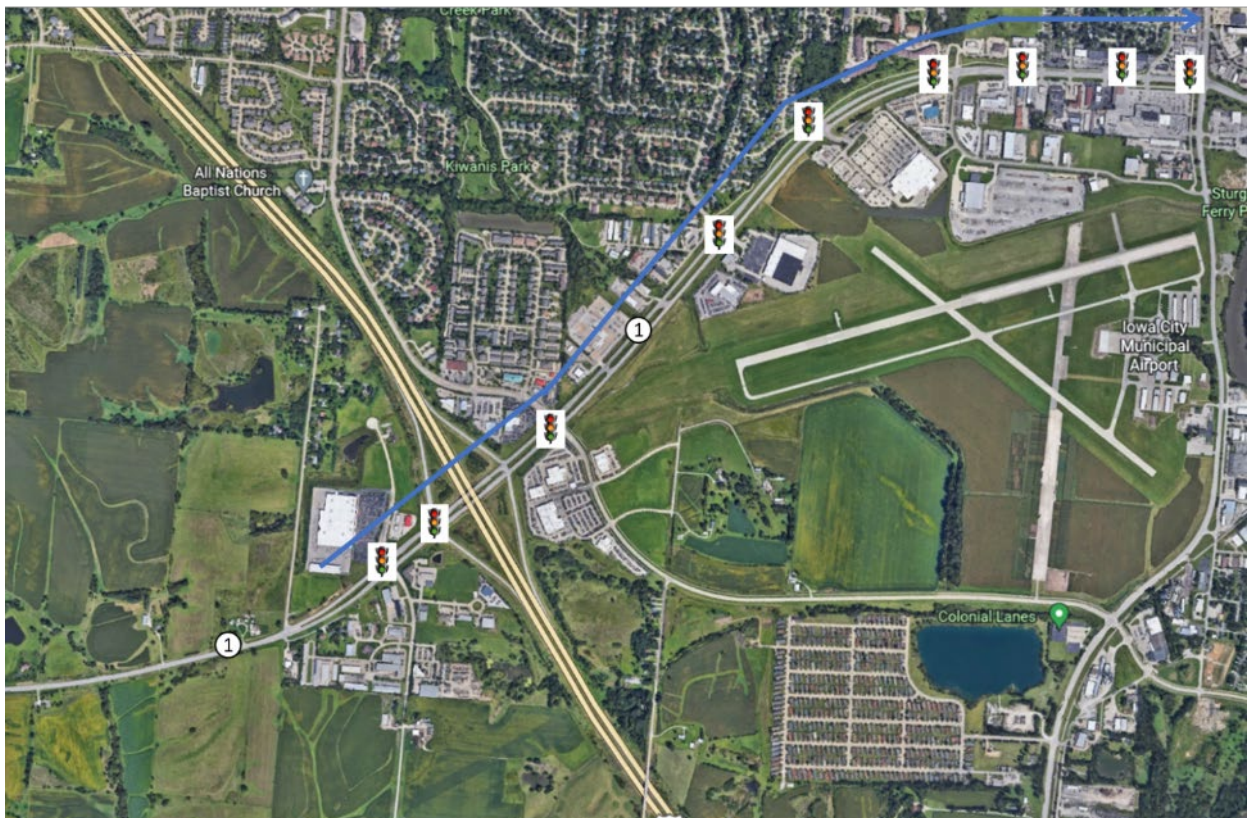
Figure 14. Traffic signals on Hwy 1

The vehicle encountered 24 traffic signals when traveling through the Iowa City portion of the route. There are nine traffic signals on Hwy 1 entering Iowa City (Figure 14). For all of these intersections, the vehicle travels straight through the intersection.

- Hwy 1 and Naples Ave SW
- Hwy 1 and the on/off ramps to Hwy 218
- Hwy 1 and Mormon Trek Blvd
- Hwy 1 and Sunset St
- Hwy 1 and Westport Plz
- Hwy 1 and Ruppert Rd
- Hwy 1 and Miller Ave
- Hwy 1 and Orchard St
- Hwy 1 and S Riverside Dr

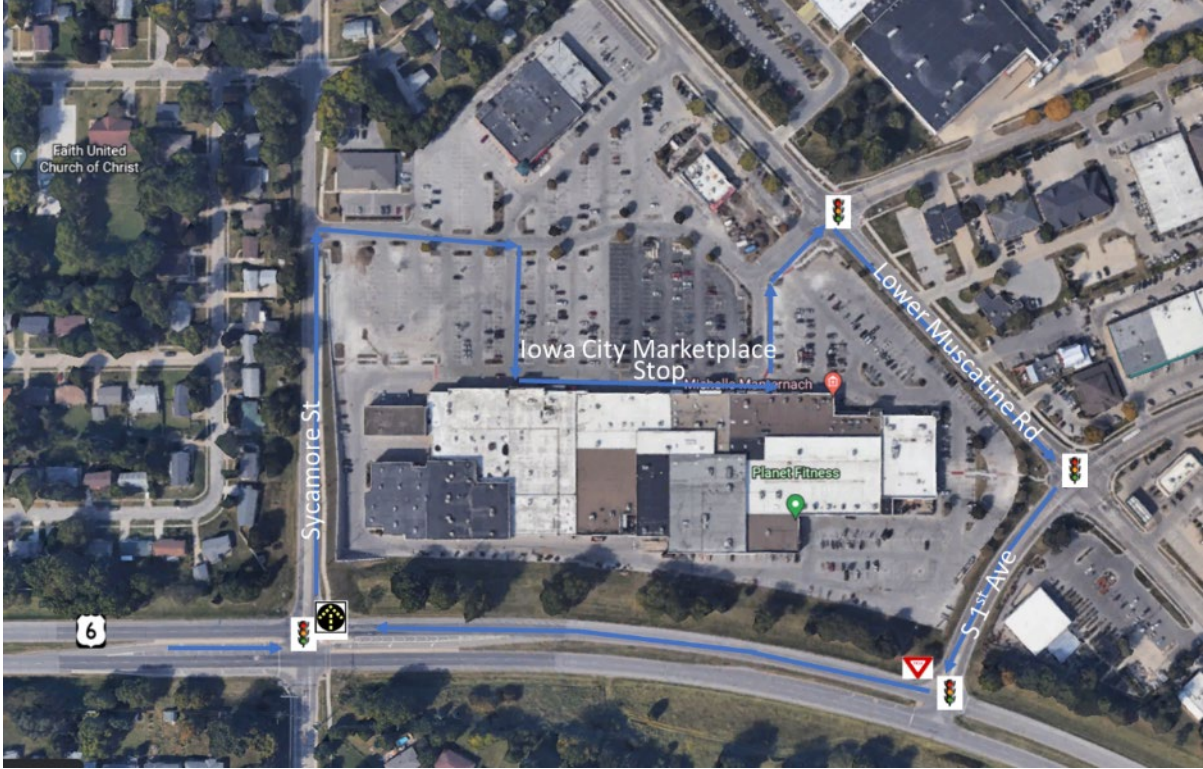
Figure 16. Traffic signals around the Iowa City Marketplace

At the intersection of Hwy 6 and Sycamore St, while heading east, the vehicle encounters a traffic signal with a flashing yellow arrow option in addition to the standard red, yellow, and green (Figure 16). The flashing yellow arrow means drivers are allowed to turn left after yielding to all oncoming traffic and to any pedestrians in the crosswalk. Drivers must wait for a safe gap in oncoming traffic before turning. The vehicle was not able to discern a yellow light from a flashing yellow arrow and therefore would not turn left unless the traffic light was green. When the vehicle approached this light with traffic behind it, the safety driver would take the vehicle out of automation in order to avoid frustrating the driver(s) behind and proceed through the intersection in manual mode.

Leaving the Iowa City Marketplace parking lot, the vehicle turns right at the traffic light onto Lower Muscatine Rd. and then turns right at the next traffic light onto S 1st Avenue. The vehicle then encounters an intersection where traffic turning left must wait for the light, but traffic turning right has only a yield sign (Figure 16).

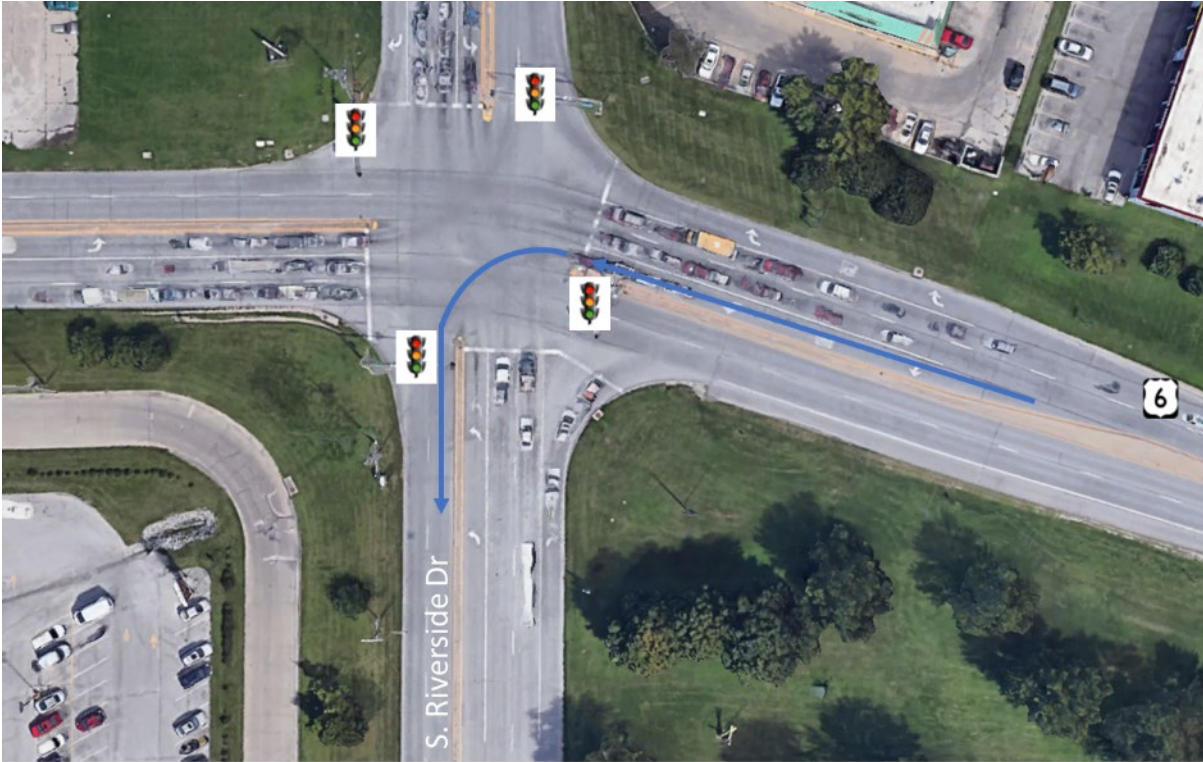
Additional traffic signals include one at the intersection of Hwy 6 and S Riverside Dr where the vehicle had previously gone straight when heading east, but the route requires that the vehicle make a left turn to head south onto S Riverside Dr (Figure 17).

Figure 17. Traffic signal at Hwy 6 and S Riverside Dr

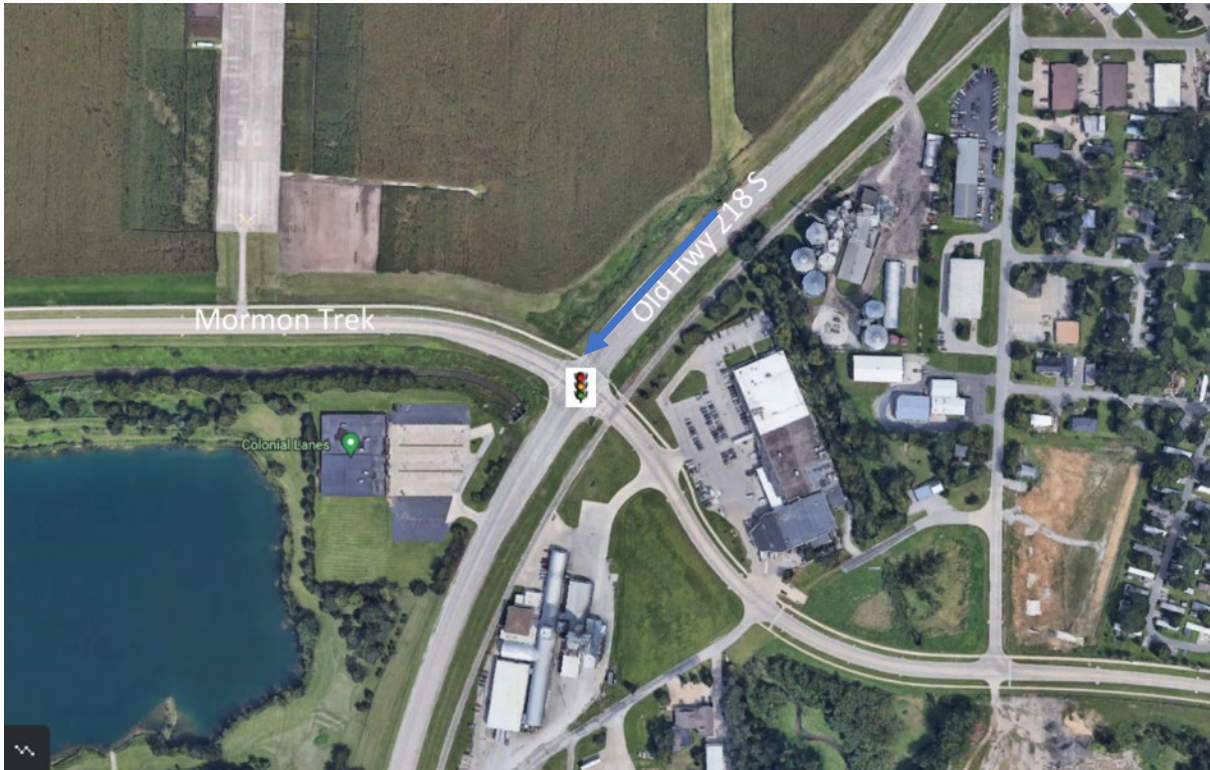
One additional traffic signal was encountered while traveling south on Old Hwy 218 S (previously S Riverside Dr) at the intersection of Mormon Trek (Figure 18). The vehicle traveled straight through this intersection.

Figure 18. Traffic signal at Old Hwy 218 S and Mormon Trek Blvd

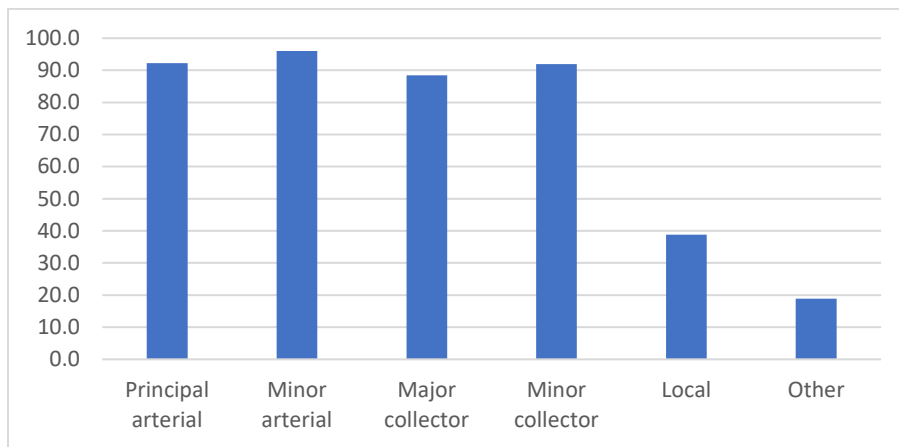
Figure 38. Percentage of FCC road type completed in automation (average across phase)

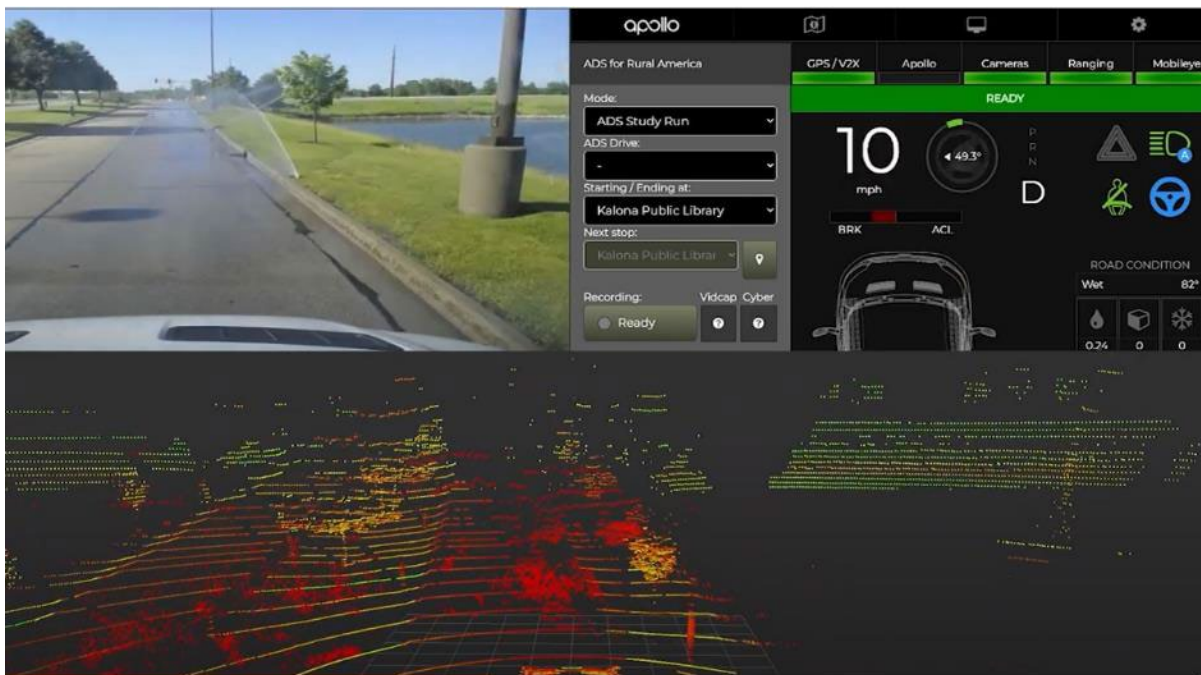
Figure 57. Point cloud
