ADS FOR RURAL AMERICA

Phase 4 (Unmarked Roads)

Evaluation Report

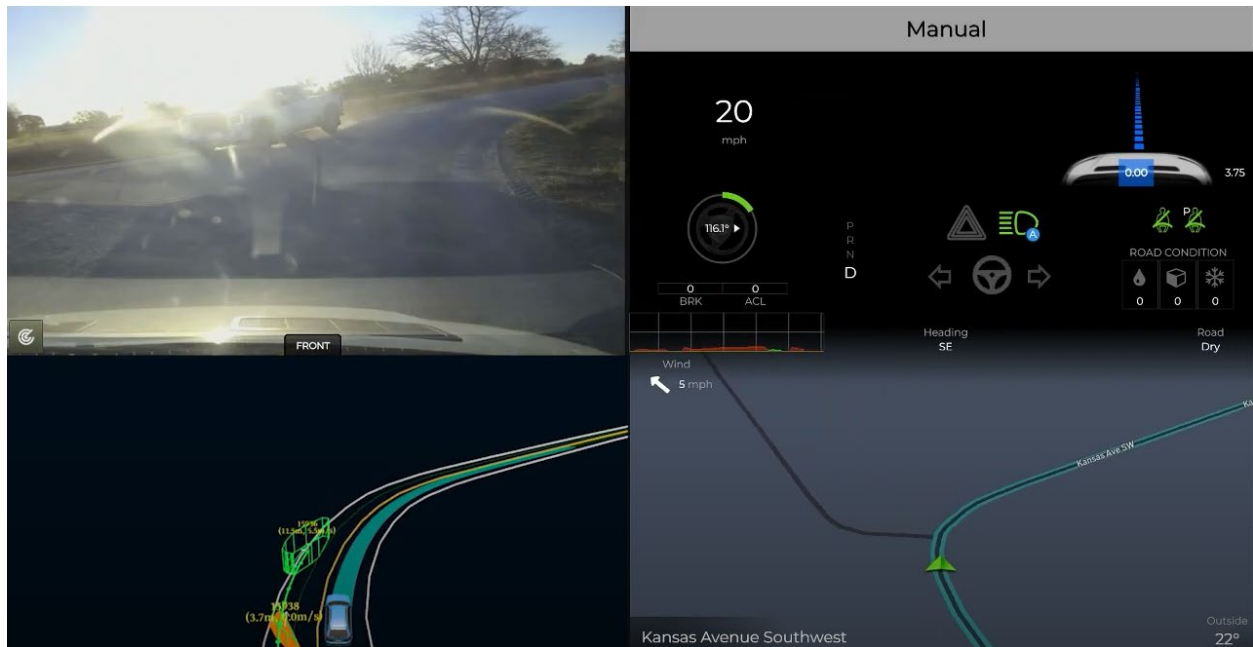
The vehicle was able to navigate the gravel road in automation 99% of the miles driven on this roadway. It encountered an oncoming vehicle twice during the ten drives. For one of those encounters (Drive 53), the vehicle encountered a large semi and was able to remain in automated mode and successfully pass (Figure 2). The other encounter (Drive 56) happened on the S-curve on a hill. This is one of the most challenging locations, in general. And with the glare and the location that the passing would take place, the safety driver felt that it was unsafe to leave it in automation for this encounter (Figure 3).

Figure 3. Vehicle encounter with pickup on S-curve on gravel road (Drive 56), <https://www.youtube.com/watch?v=ldujaEljy5g>

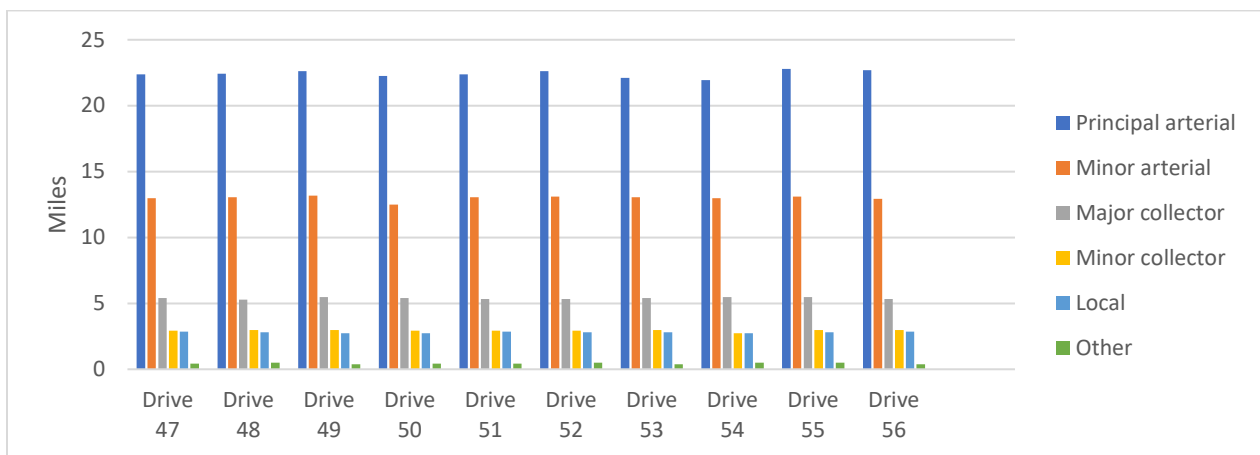
Overall, the number of miles driven in automation by federal function classification (FFC) of road types is shown per drive below (Figure 18). For this phase, more than 90% of the miles for all road types, except for “other,” which is considered parking lots, were driven in automation (Figure 19).

Figure 18. Miles driven in automated mode by FCC road type

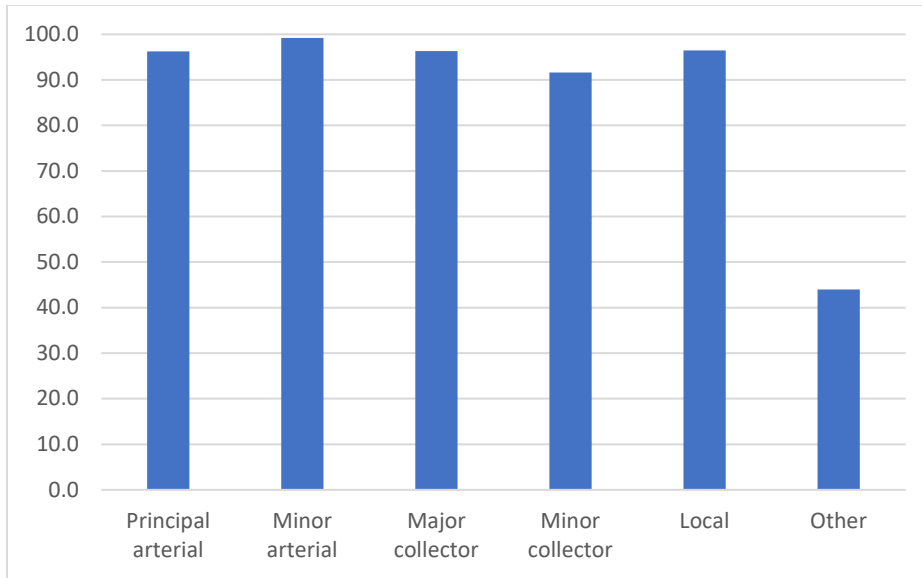
Figure 19. Percentage of FCC road type completed in automation (average across Phase 4)

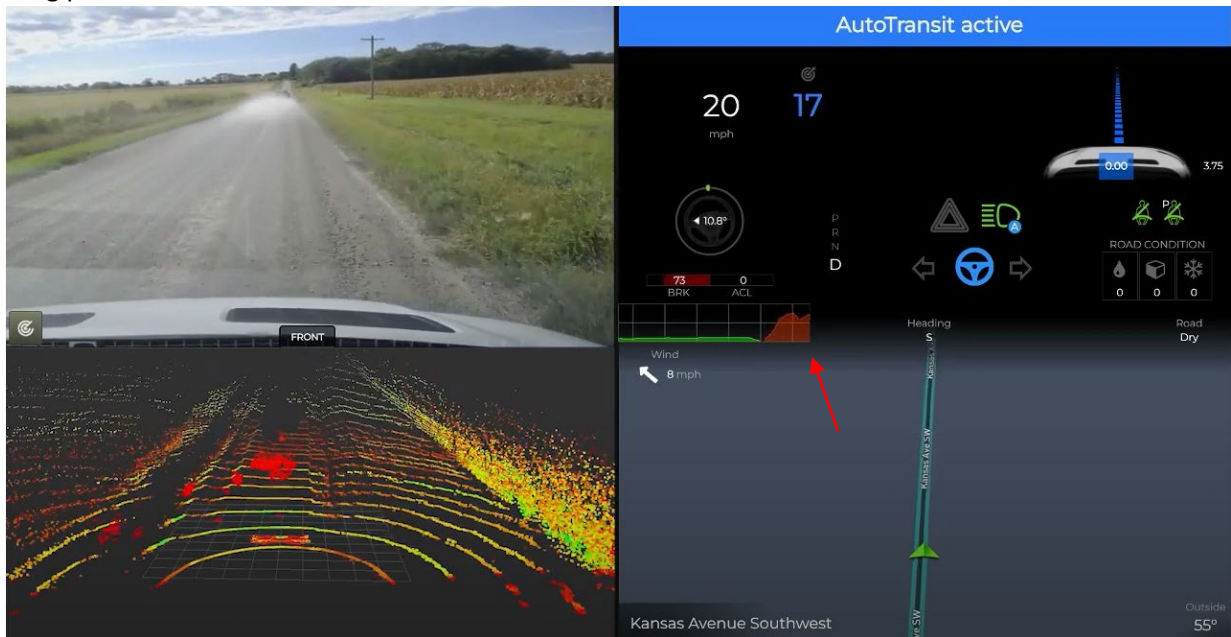
Similar to the water spray from Phase 3, gravel dust could be an issue for the LiDAR. The screenshot (Figure 40) was taken from a video recorded during one of the practice drives before the start of Phase 4. It shows the dust being detected by the LiDAR. The top right portion of the screenshot shows that the vehicle does some rather hard braking (see the red arrow) due to the unknown “obstruction” that was being perceived in the road ahead.

Figure 40. Point cloud showing gravel dust
<https://www.youtube.com/watch?v=TnvRclBG1rg>

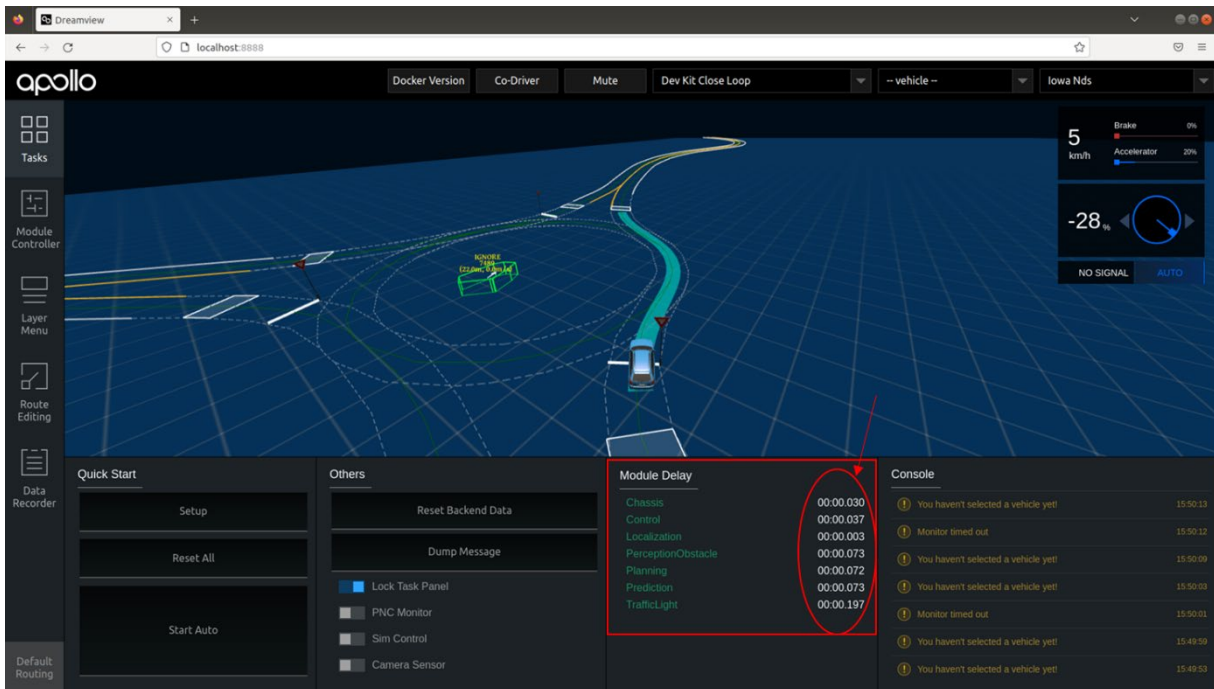
During safety driver testing leading up to Phase 4, there was one instance of the vehicle drifting out of its lane without any indication to the driver that an Apollo module had failed. To mitigate this, the system's health from a software perspective is now monitored. Apollo's web-based HMI and interface tool, Dreamview, can subscribe to the output topics (messages) of every Apollo module. The delay in between two consecutive messages is computed and displayed in Dreamview (Figure 41). If the module's delay is higher than a predefined threshold, the number will be rendered in a red color as a warning to the user. Normally they are rendered in a white color. In this phase, our technology partner AutonomouStuff added an audible warning prompt if the delay for Localization or Perception modules is over 1.5 seconds.

Figure 41. Dreamview showing the delay calculated between consecutive messages
