ADS FOR RURAL AMERICA

Phase 5 (Connected Vehicles)

Evaluation Report

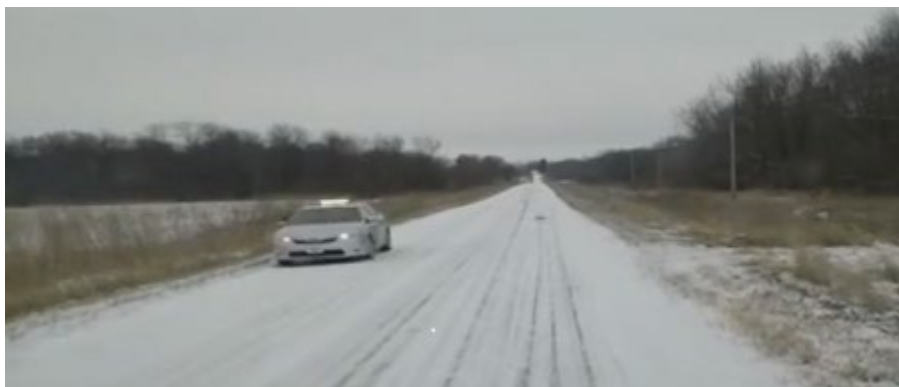
Figure 1. Confederate vehicle

The goal of Phase 5 was to demonstrate the ability to provide real-time driver alerts for slow-moving or stopped vehicles along a route and to have the AV respond to these alerts. We had originally sought to instrument two school buses from districts that would travel along our route but were unsuccessful in this endeavor. Therefore, to accomplish our goal for this phase, a confederate vehicle (Figure 1), driven by another one of the UI safety drivers, was equipped with flashers to emulate a stopped school bus along our route.

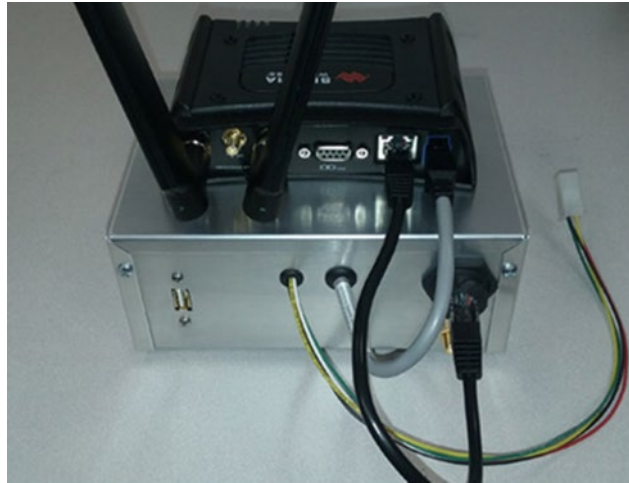
Additionally, both the Transit and the confederate vehicle were instrumented with an on-board telemetry processor (Figure 2). This processor could be easily mounted inside the vehicles and needed no external user interaction. It started when the vehicle's ignition was turned on and shut down when the engine was turned off.

Figure 2. On-board telemetry processor

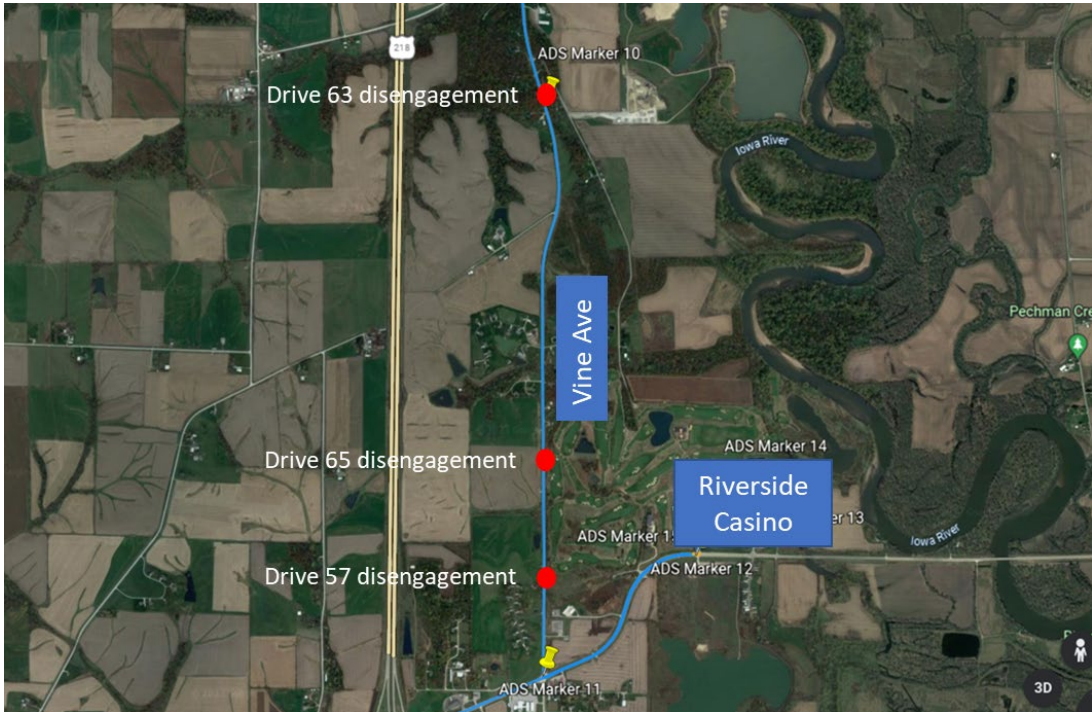
Situations where the automated driving system (ADS) disengages on its own or becomes unavailable and requires the driver to intervene are called forced takeovers. There were four instances of this type of takeover during Phase 5: three occurred at different locations on Vine Avenue (Figure 21) and one that occurred on State Hwy 1 (Figure 22). In each of these instances the driver was warned with an auditory beep. In the previous phase, this type of failure happened once on Vine Ave (see the Phase 4 report for additional details). It was hypothesized that the failure may be due to electromagnetic interference with

Figure 21. Forced takeovers on Vine Ave

the PACMod system. Therefore, the PACMod was wrapped with materials to shield the internal electronics from electromagnetic interference, and this type of unexpected disengagement did not happen for the remainder of Phase 4. However, the return of this failure in Phase 5 means that interference was likely not the cause and the reason for these forced takeovers is still under investigation.

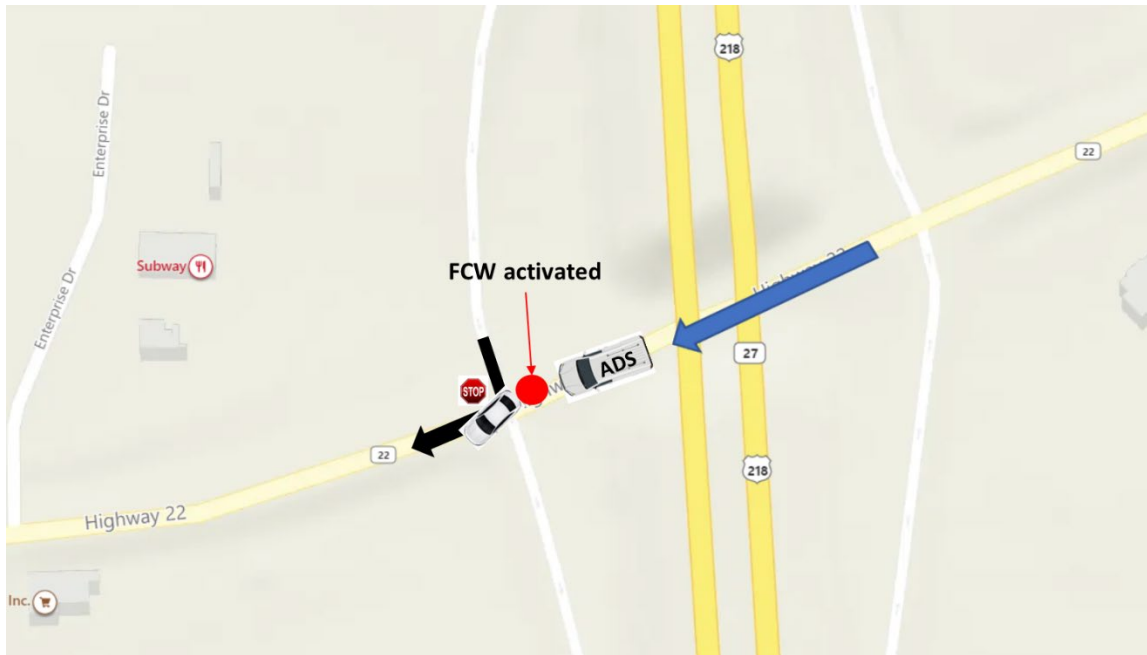
These events include interactions that require abrupt accelerations/decelerations or large steering wheel reversals by the automated vehicle (AV), the safety driver, or another vehicle and may or may not be classified as a near crash. Crashes are also included in this category. There were two safety critical events recorded during Phase 5. The first safety critical event occurred during Drive 60 (Figure 23). After leaving the Riverside Casino and heading west on State Hwy 22, a vehicle that had been stopped at the stop sign at the intersection of the Hwy 218 off ramp and Hwy 22 pulled out to head west in front of the Transit. The forward collision warning, part of the Mobileye system, was activated, and the safety driver was required to brake hard to avoid a collision.

Figure 23. Drive 60 safety critical event with forward collision warning (FCW) activation
