ADS FOR RURAL AMERICA

Phase 6 (Parking Areas/Full Route)

Evaluation Report

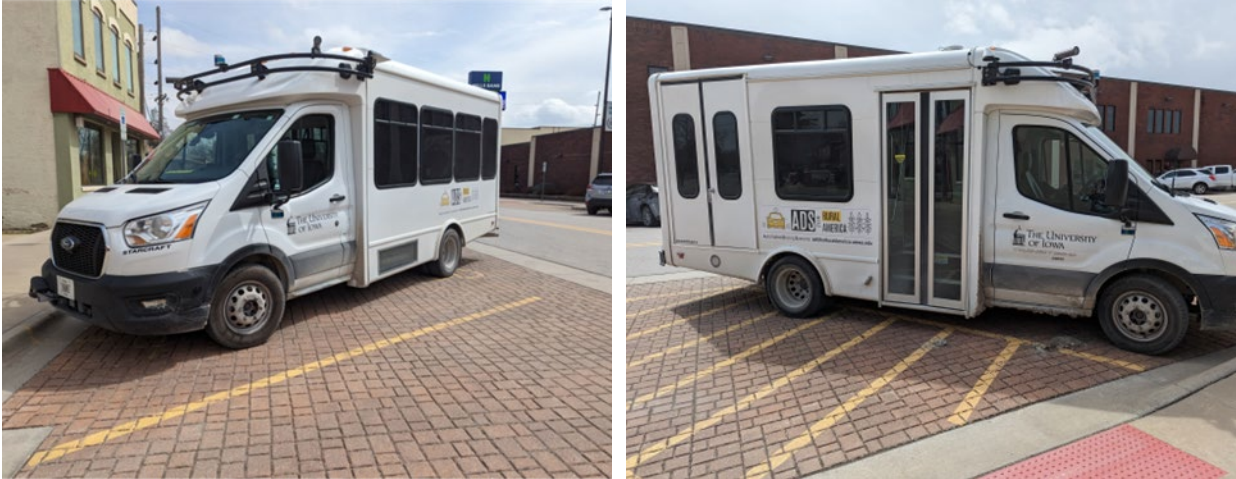
Figure 2. Angle parking at Hills Community Center

The AV was able to successfully park at the Hills Community Center nine out of the twenty drives. The other eleven attempts were unsuccessful for a variety of reasons (Table 1). The majority of the time it was due to a curb strike or failure to stop at the end of the parking maneuver.

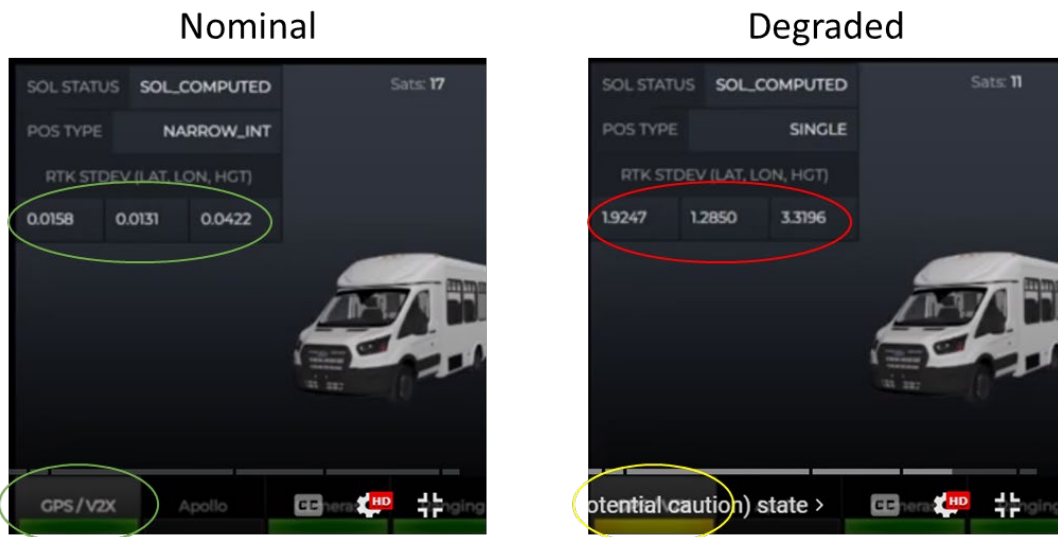
Figure 19. GPS data showing nominal and degraded RTK performance

The lower right portion of the video is a cropped version of the safety driver’s display (Figure 19), showing the GPS RTK solution degrading and what was be seen by the co-pilot at the time. Specifically, looking at the fields labeled “RTK STDEV (LAT, LON, HGT)” where larger numbers are bad. The display also changes from green to yellow for GPS/V2X.

Drive 73 had the lowest percentage completed in automation. A portion of the drive on Hwy 1 (shown in yellow in Figure 19) had to be driven manually due to degradation of the GPS/RTK. This degradation caused the vehicle to drift gradually toward the right lane boundary and eventually crossed over the lane boundary hitting the rumble strips at approximately 6 minutes into the video. The YouTube link (https://www.youtube.com/watch?v=Fp4v520C_Xk) is split into chapters that describe what is happening in the drive.

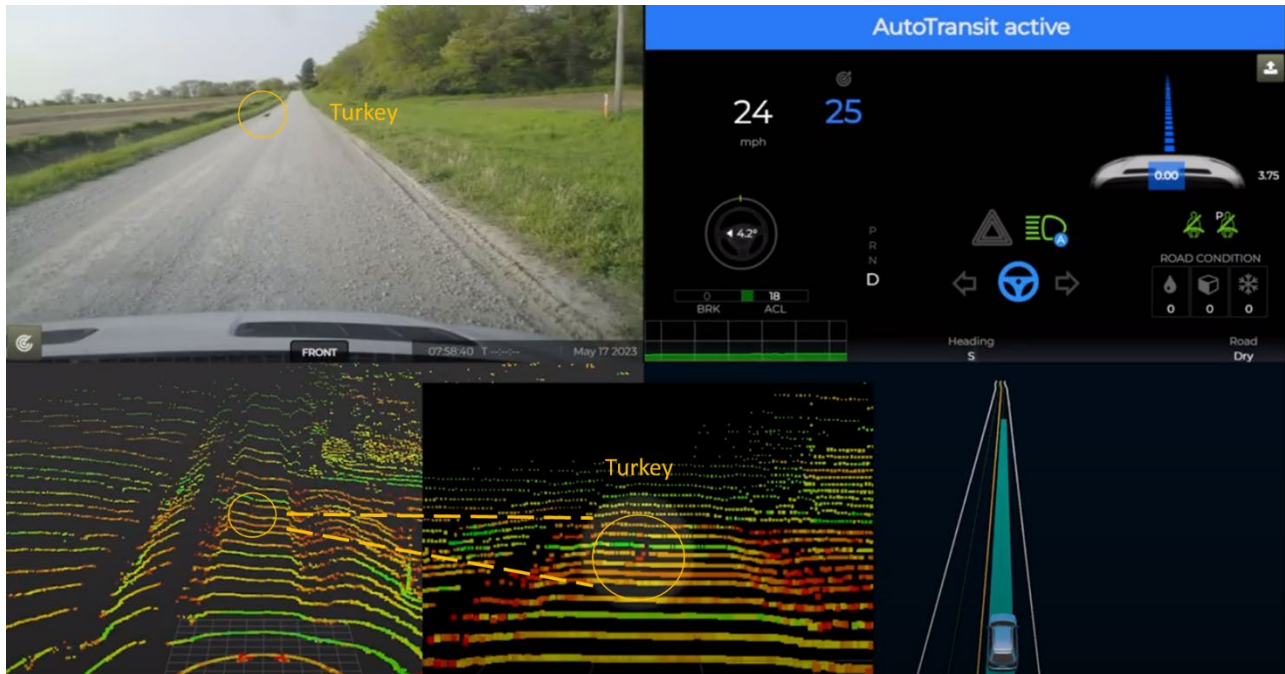
Figure 56. Turkey in roadway

Interestingly, during Drive 80, the Transit encountered a turkey running across the gravel road ahead (<https://www.youtube.com/watch?v=JooExCfYnlk>). The turkey shows in the point cloud visualization, but Apollo didn't classify it or seem to do any steering/braking (Figure 56).
